Identification of corrosion of galvanized pipes in the water supply system

A. P. Andrianov¹, V. A. Chukhin²

The data on the research and application of a new method for identifying corrosion of house water plumbing made of galvanized steel pipes are presented. The method can be used for regular monitoring of the technical condition of cold and hot water supply systems made of galvanized steel pipes in residential, public and industrial buildings. The method is based on determining corrosion products of pipelines and equipment, zinc and copper in particular, on a indicator specimen. The technical result of the proposed solution is the possibility of its application directly from the start of the operation of the water supply system as well as reducing the time to identify the occurrence of corrosion of pipelines and equipment during long-term operation.

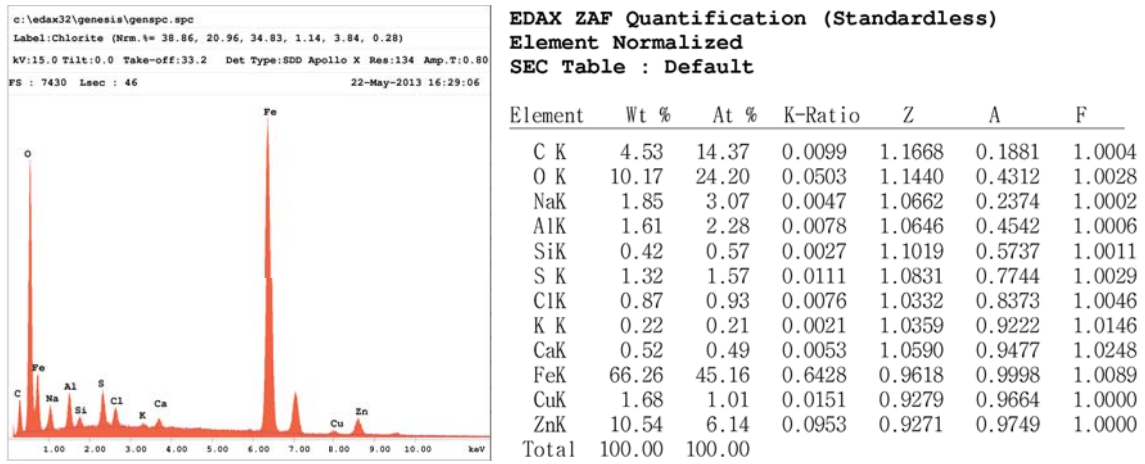
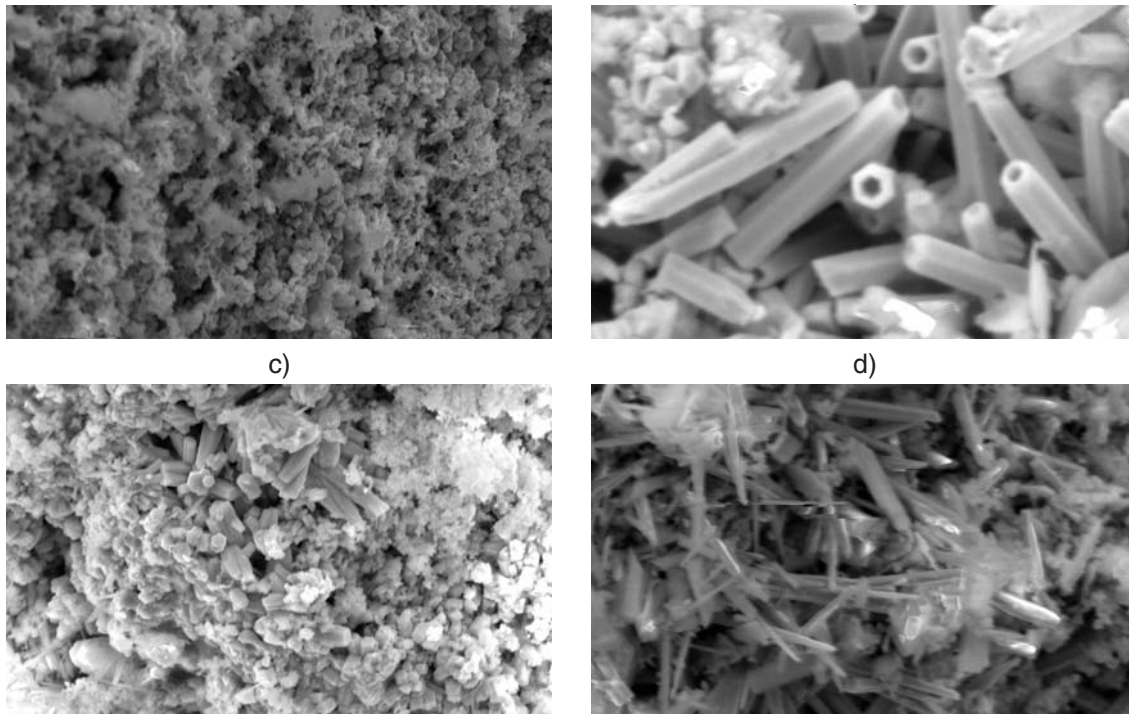
Fig. 1. Spectrogram, chemical composition and micrographs of deposits taken from a pipe of a hot water supply system

a – through damages; *b, c, d* – fragments of the surface of a galvanized pipe with broken zinc coating

In the process of inspecting water supply systems with signs of corrosion [8; 9] with the use of advanced instrumental analysis tools it was found that a large amount of zinc and, in some cases, copper is contained in corrosion deposit. Deposit samples were taken from various sites directly during repair works. Deposits removed from the aerator of the mixer of the hot water supply system of an individual residential building contained zinc in a concentration of about 37% by weight. The cause of corrosion was current leakage due to a malfunctioning electric heater. Figure 1 shows a spectrogram, microphotographs, and chemical composition of the deposits taken at one of the inspected projects from the inner surface of the corroded pipeline.

From the represented data on the elemental composition and micrograph (Fig. 1, *a*) it is evident that the deposits covering the pipe surface contain zinc and have a porous structure that does not interfere with the penetration of oxygen. Therefore, the initiated corrosion will continue until through-holes appear. Zinc detected in the deposits was both in amorphous form and in the form of crystals. Figure 1, *b* shows a photomicrograph of a corroded zinc layer coating of a pipe 100 mm in diameter representing zinc oxide crystals of ZnO . Obviously, this is one of the zinc layers formed during hot galvanizing, namely ζ -phase.

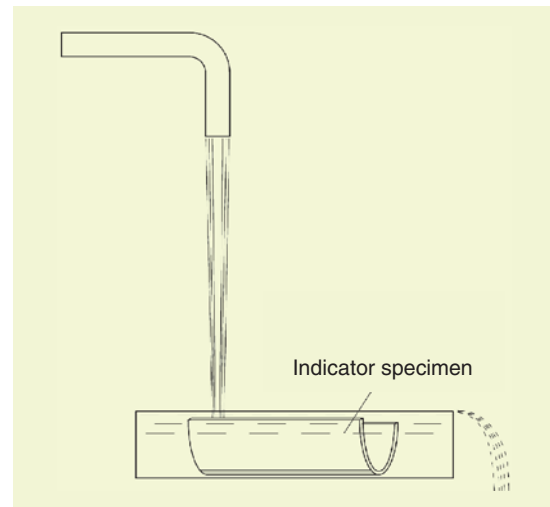
Fig. 2. Design of the experiment

Figure 2 represents a flow scheme that was used for determining the corrosion rate and analyzing the composition of corrosion deposits on the indicator specimen.

The prepared indicator specimen was placed in a container under a stream of cold tap water for 2–6 hours with a minimum flow rate of 20–25 l/h to provide for a solid jet. The jet fell from a height of 20–30 cm onto the inner surface of the specimen that was subsequently subject to analysis (Fig. 2). The second specimen was placed under a hot water jet under the same conditions. The container where the indicator specimens were placed should ensure their complete immersion in water and continuous contact with running water. The material of the container should not react with water (glass, ceramics, plastic, etc.).
